A GUIDE
TO
EROSION REDUCTION
ON
NATIONAL FOREST
TIMBER SALE AREAS

U.S. FOREST SERVICE
CALIFORNIA REGION
1954

R. P. McRorey California Region
N. F. Meadowcroft California Region
C. J. Kraebel California Forest and
 Range Experiment Station

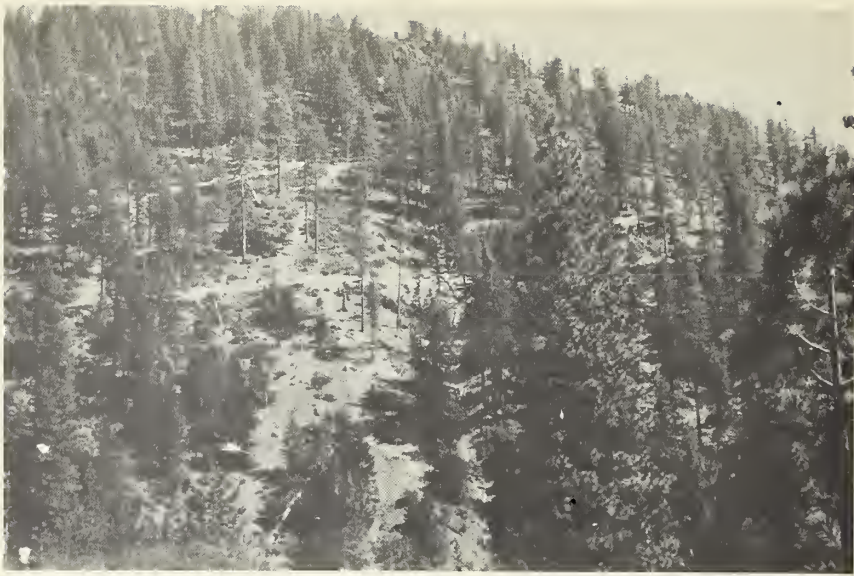
1.

Cut-over area on very steep ground with slopes up to 70 percent. As the result of careful planning, advance location and construction of the road and tractor trails, logging has been done without serious erosion or other damage to the watershed.

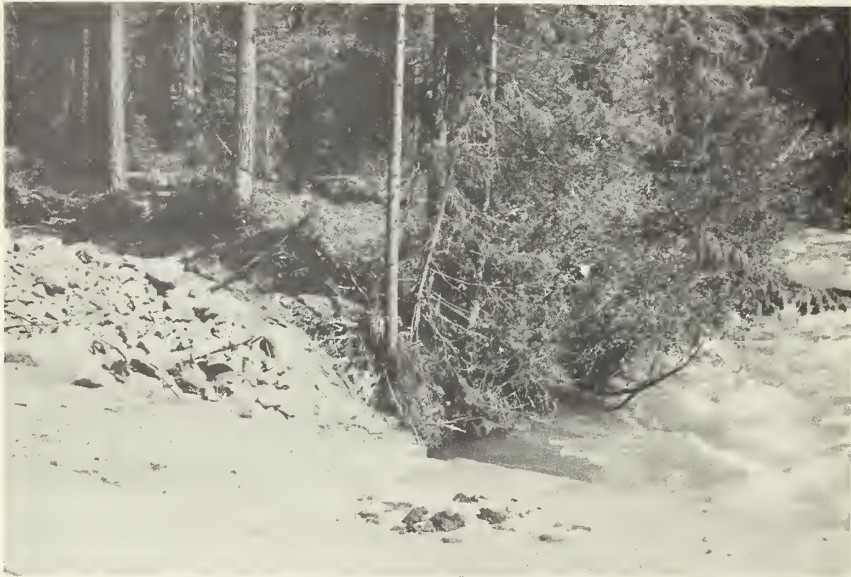
2.

Protective strip of vegetation about 50 feet wide left along a stream to protect banks and preserve natural conditions for fish, wildlife, and attractive appearance. A very desirable practice anywhere, but especially so near recreation areas and adjacent to highways. The surrounding area in this instance was heavily logged.

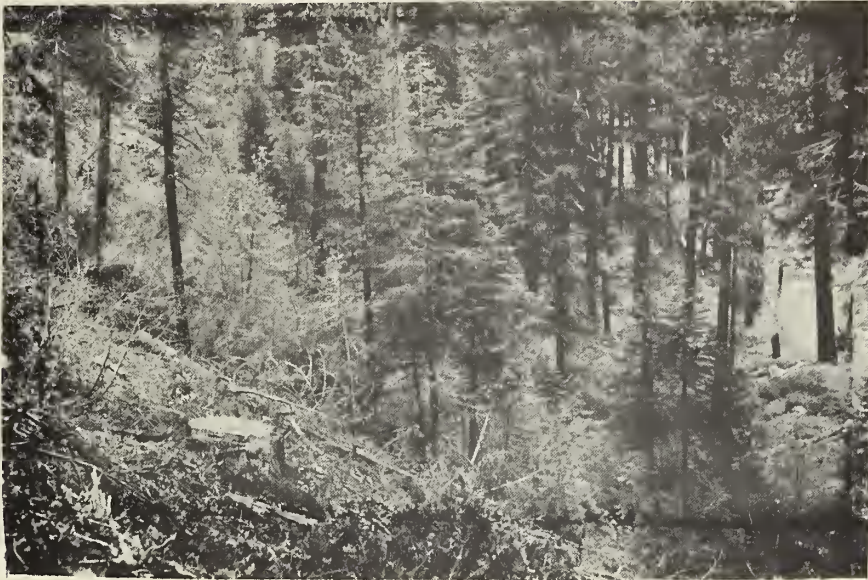
3.

Protection or "leave" strip along slope adjoining a creek. Area upslope at left was heavily cut. Protection strips like this help preserve favorable conditions for fish, wildlife, and recreation where these values are important.

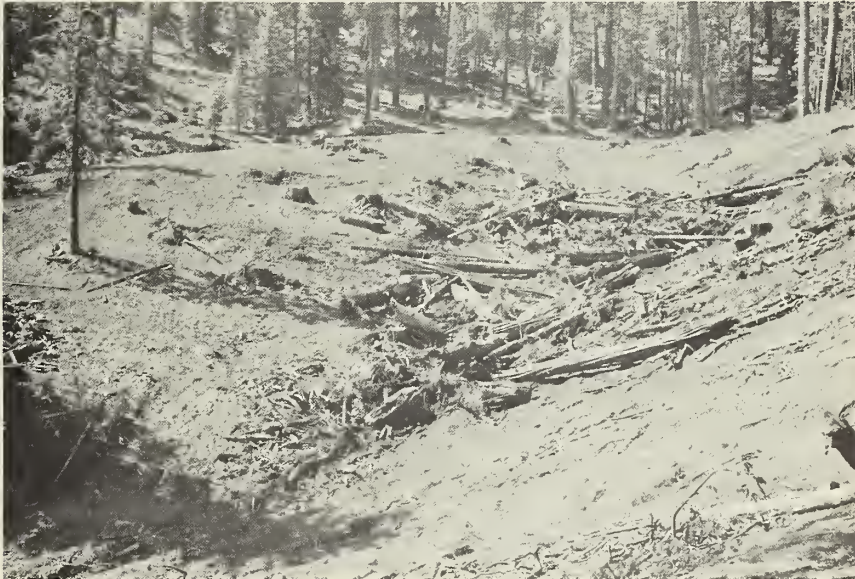
4

A clear cut "unit area," well handled, on a moderate slope at head of a ravine with intermittent streamflow. After logging, the ground surface was stripped of competing brush and undesired trees. Most of the slash was burned, but a small amount was pushed into the draw to check runoff and trap any eroded material, then the cleared area was seeded and planted. For good watershed management this method is not advisable for areas larger than about 5 acres, nor for very steep slopes, or erodible soil, unless special precautions are taken to control runoff and erosion.

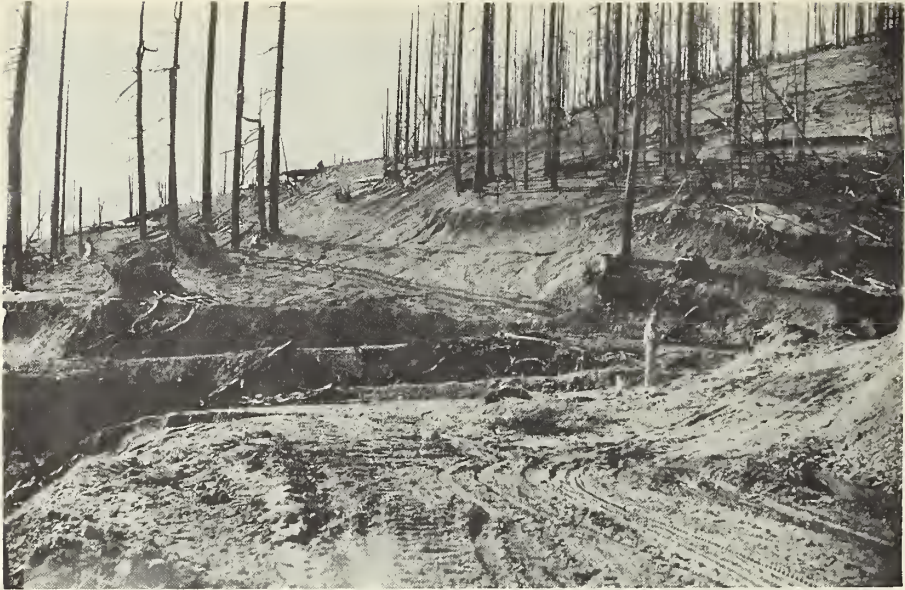
5.

Washout of fill across a stream in salvage area, after logging, necessitated reconstruction of the road to give access for planting and seeding. Such washouts occurred at a score of crossings on three contour roads in this burn, the eroded material coming to rest in a power reservoir 3 miles away.

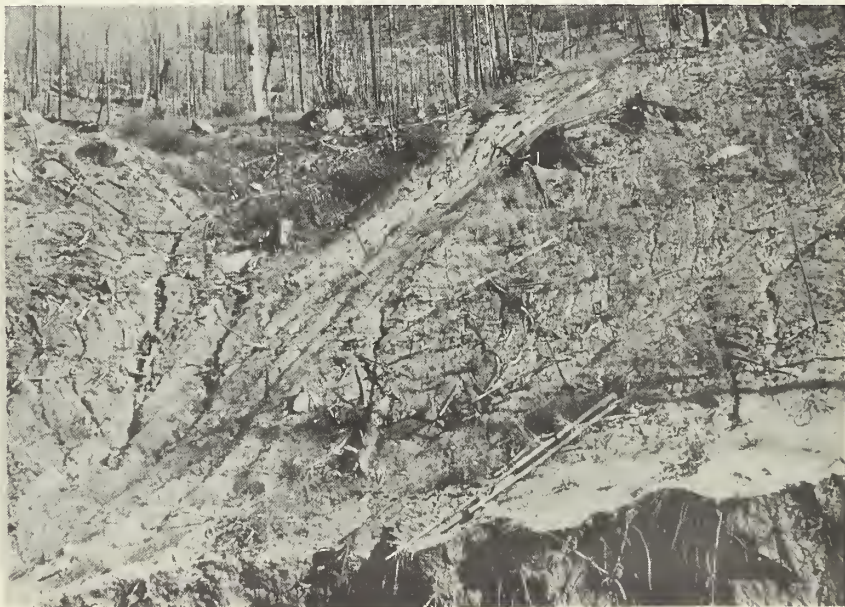
6.

Severe erosion in a burned area aggravated by a timber salvage operation. Note the rill erosion down the skid trails and edge of a large gully in foreground caused by a road. In the interest of good watershed management, careful consideration should be given as to whether logging in such an area is justified, and whether adequate treatment can be provided to prevent excessive damage.

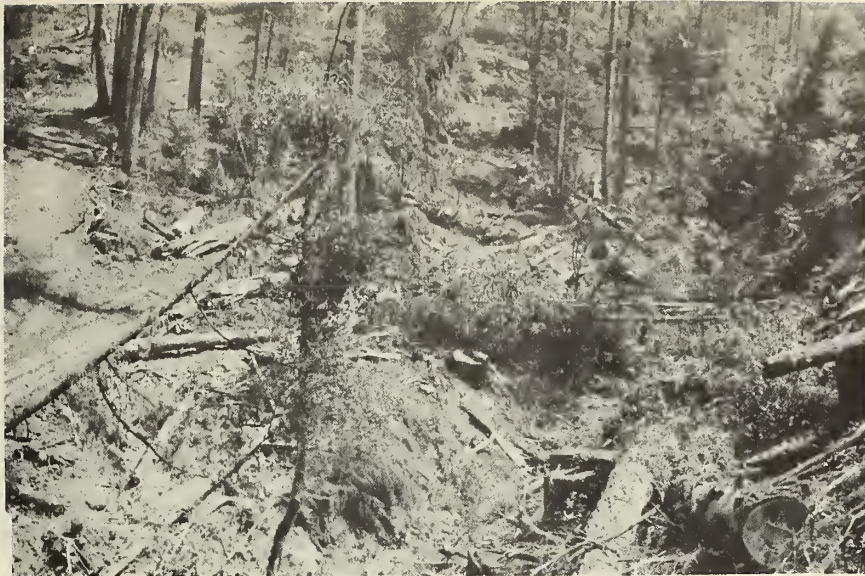
7.

Stream channel heavily obstructed by logging slash and erosion debris from heavy cutting. Logging waste dumped indiscriminately in streams in this manner destroys their fishing and recreation values and creates a severe fire hazard.

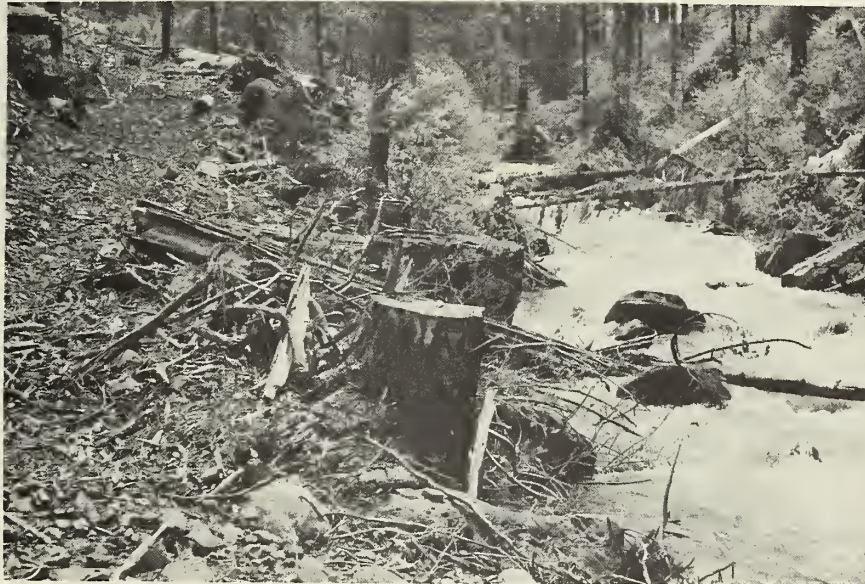
8.

Heavy cutting along this main stream was done with very little disturbance of banks or channel. The trees were felled away from the stream and hauled out over the tractor road at left, located well above water level. Most of the logs on the far side of stream were skidded to a road 200 to 300 feet up the slope at right. Broadleaf vegetation left along the streambanks, and released by removal of the conifers, will soon shade the stream.

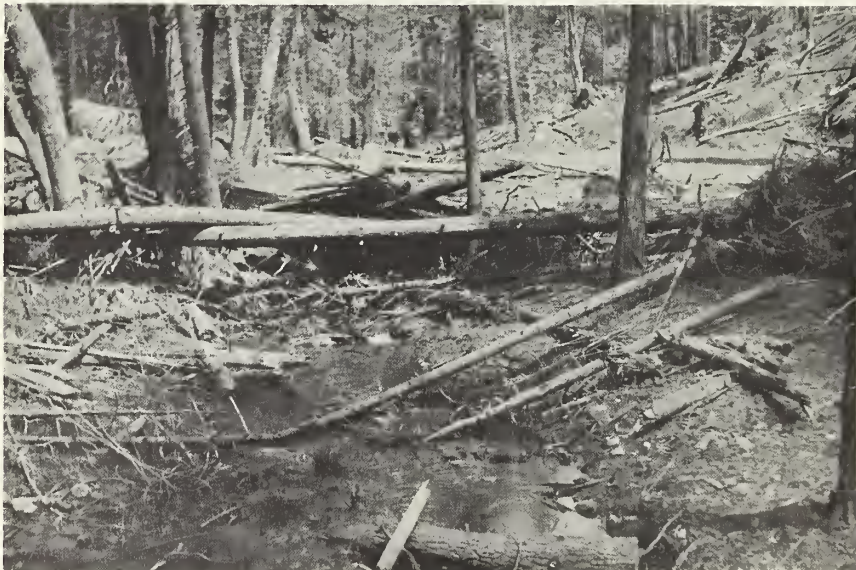
10.

A small stream, choked with silt and logging debris, and with all riparian vegetation destroyed. Care in logging along the stream and on the watershed to reduce these damages would have entailed little additional expense.

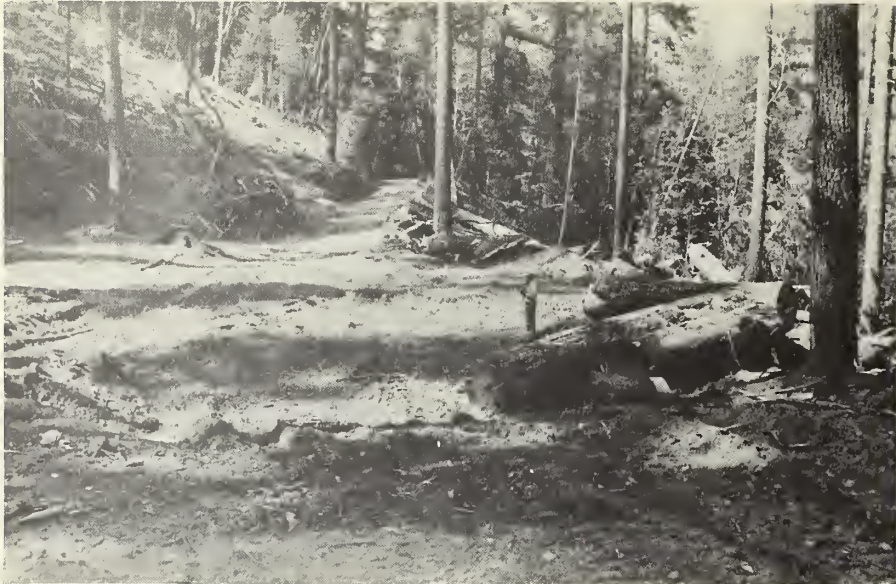
11.

Excellent example of large landing in dry ravine at end of road, made level from road excavation. The road slopes toward landing. Drainage dip on opposite side, at junction of landing and road, carries local runoff over edge into logging debris without erosion. The cull logs and organic matter at right have been well placed to prevent washout of the landing.

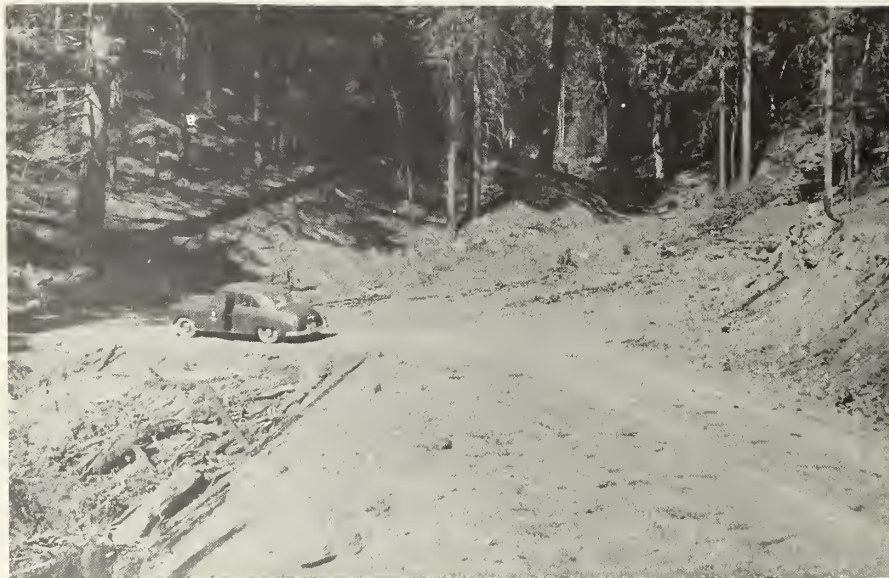
12.

Good small landing on road serving local area of dry ravine at right. Ditch across far side beyond the car carries winter runoff into debris below the road without erosion.

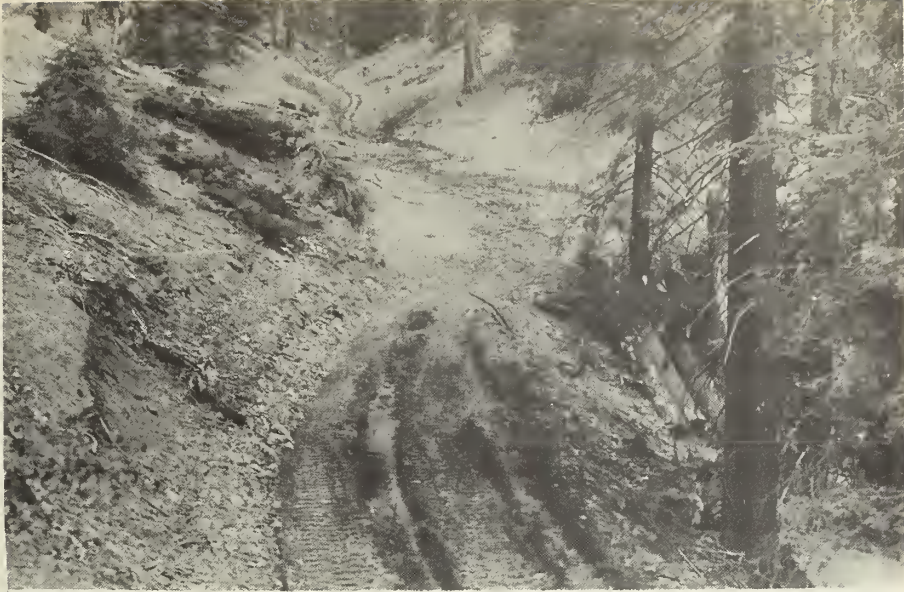
13.

Combination of skid-road, landing, and temporary road in a stream channel. No treatment whatever was applied, the result being erosion of ravine bottom and diversion of winter runoff down road and over bank in the foreground. If this placement of landing was necessary, the skid-road should have been treated with slash after logging, and a sizeable channel constructed across landing with a levee at the road junction.

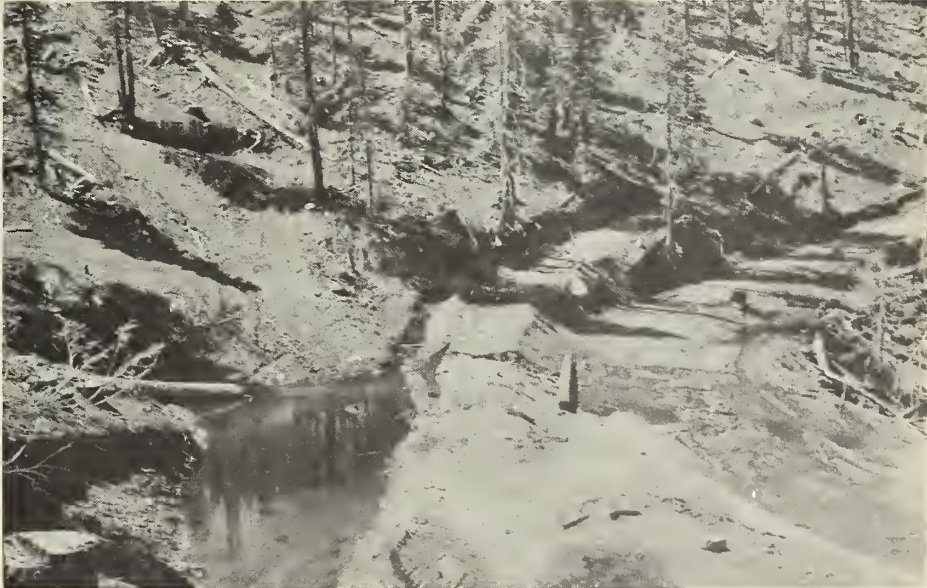
14.

Combined landing and water-hole for trucks along secondary road, as left after logging. Overflow from pool has run down road softening and eroding it for a long distance. Pool should have been drained by dip or culvert across road and emptied harmlessly into slash below the road.

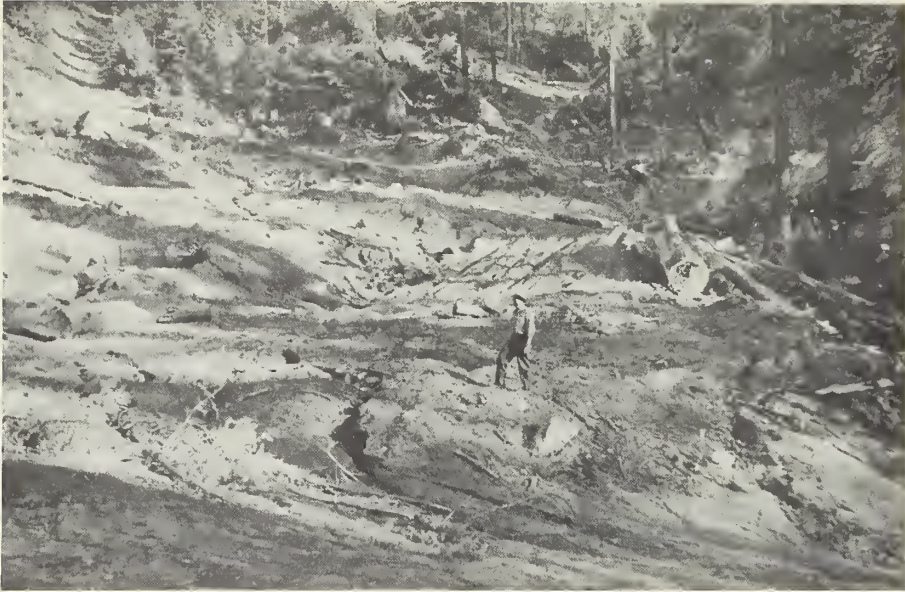
15.

Landing in disintegrated granite soil below a steep slope that was heavily cut and tractor logged - with too many skid trails, poorly located, and not drained after logging. Uncontrolled runoff from trails gullied the landing, repeatedly blocked a forest highway, and carried much sediment into a popular fishing stream. With such site conditions, extraordinary precautions in logging should have been taken, or the slope left uncut.

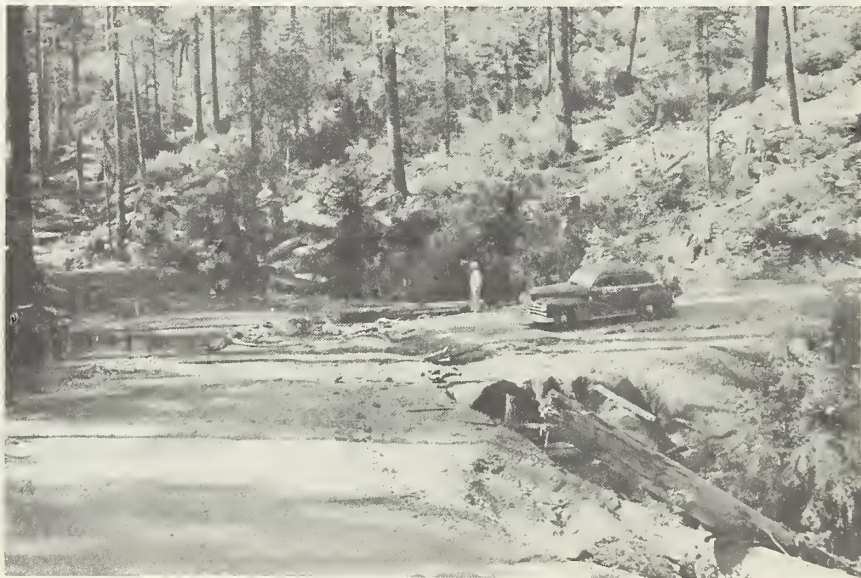
16.

Landing above a secondary road and beside a live stream. Logging slash in channel caused log fill to clog, and subsequent overflow to damage the road. Removal of the log fill and restoration of stream channel would have prevented the damage. Such simple precautions should always be taken where live streams are involved.

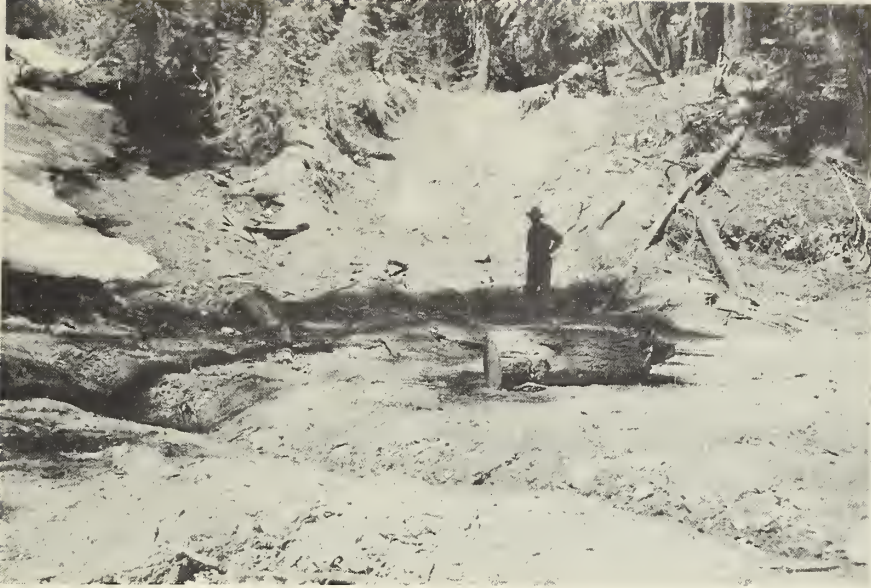
17.

Small landing along temporary road properly cleaned up, and an adequate drainage ditch constructed. Erosion is negligible and area is well established.

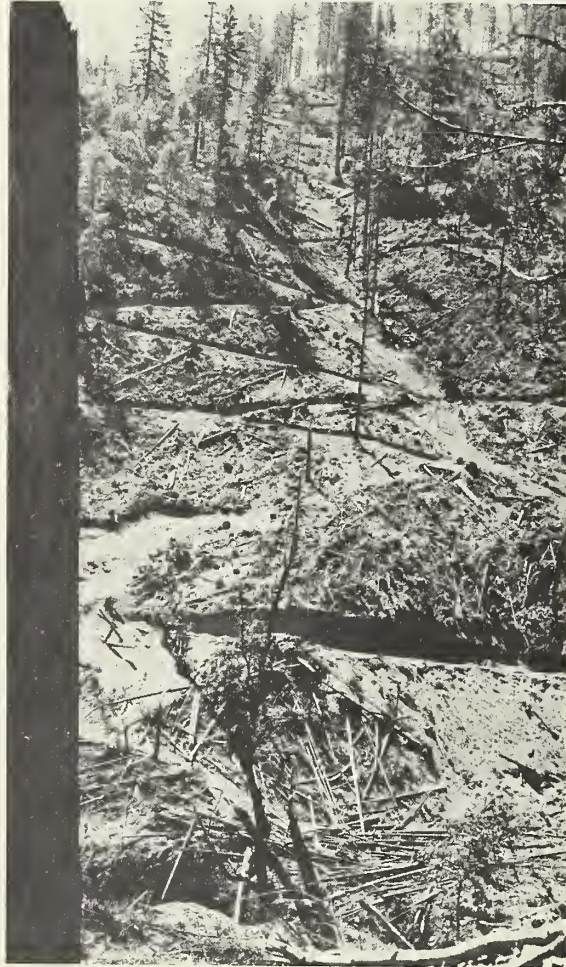
18.

In this canyon both soil and stream have taken a "beating" from the logging operation. This example is not unusual where steep topography and heavy rains aggravate watershed damages. Much of this damage could have been prevented by better planning and greater care in logging but the ultimate solution might lie in some adaptation of aerial yarding of logs by cableways.

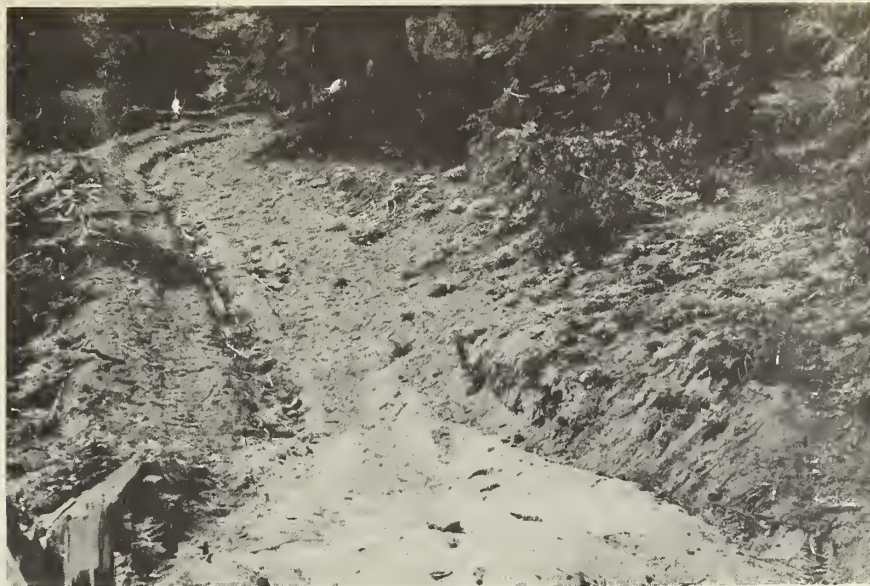
19.

Tractor road in very light (disintegrated granite) soil on 25 per cent slope. Shows erosion and accumulated sand at end of continuous one-fourth mile run. A water turn-out has since been constructed in the foreground, but additional water breaks with outlets should be installed at intervals of 100 feet, including one at the bend in the road. This skid road could and should have been constructed with several breaks in the grade.

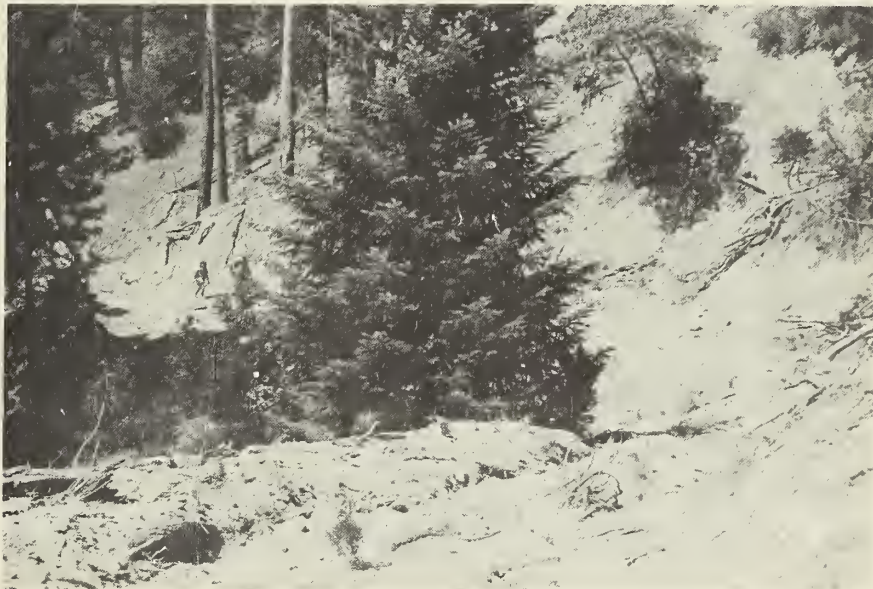
20.

Tractor road in light d. g. soil, constructed on long continuous grade (25 to 30 per cent) across several ravines in steep country. While general location is satisfactory, complete lack of drainage caused severe erosion during a very heavy rain. The grade should have been broken at each ravine crossing and all waterways properly opened up after logging. Also, water-breaks between ravines, slash in the road, and reseeding, should have been employed in this case because of the large amount of bare and highly erodible soil.

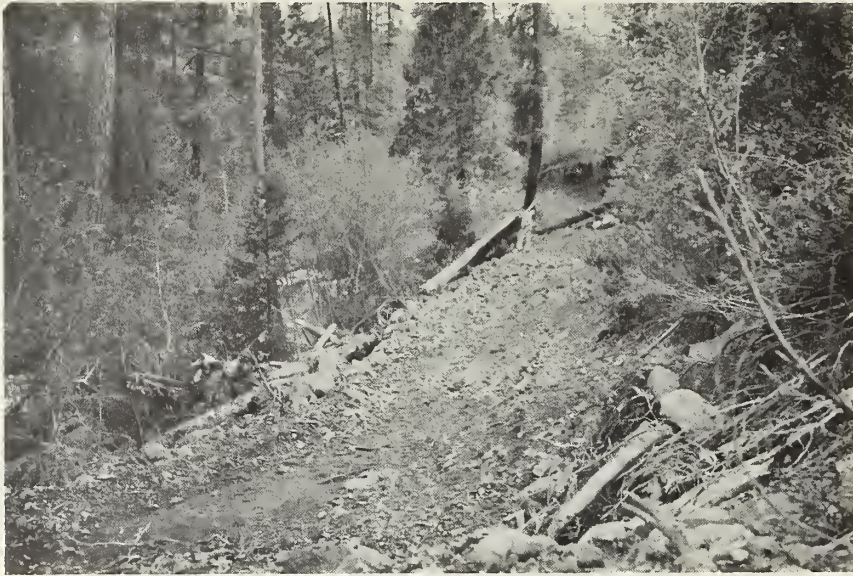
21.

Tractor road along creek. Good location, well above high water level, with a fringe of streamside vegetation, and no unnecessary soil disturbance. All logs from a large area were arch-skidded over this road, and across the creek at a single crossing just below this spot. (See Photo 25.)

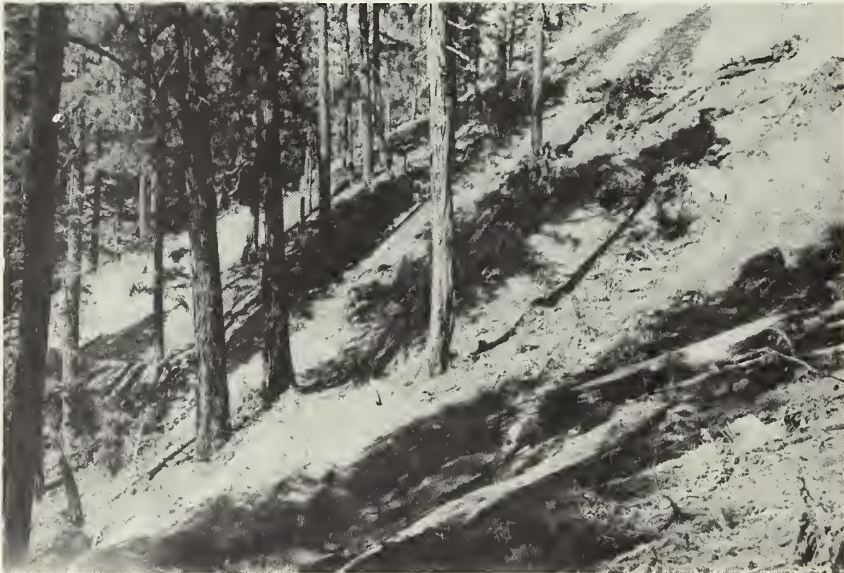
22.

Tractor road in very steep country and light soil. Good location roughly on a contour with breaks in grade, localizes drainage and minimizes erosion. Low points on the grade should always be in the ravines to prevent diversion of stream flow down the road during high stages. Photo also illustrates use of cedar (or cull tree) for a bumper or rub tree where tractor road turns.

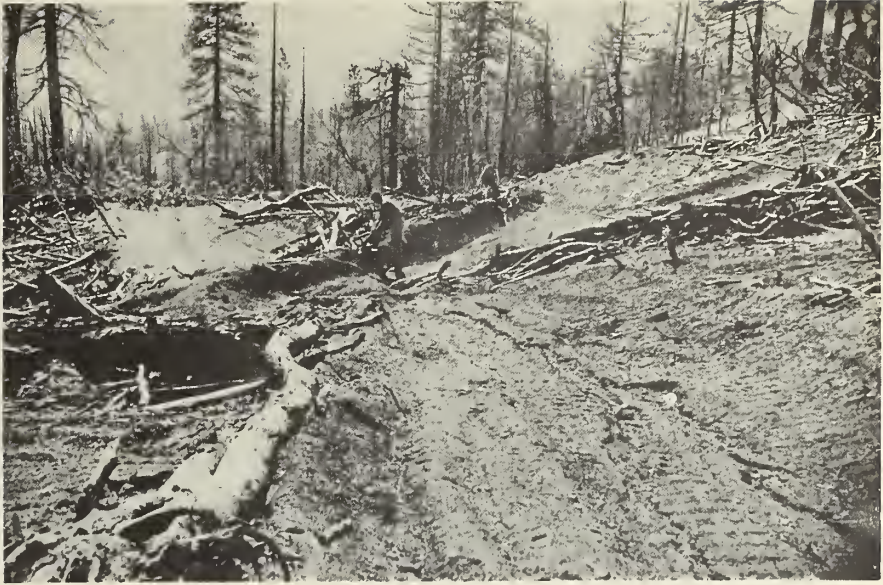
23.

Tractor road in a salvage logging area showing a well constructed water-break. This should have been augmented by placement of slash across the road in foreground to prevent rill erosion. In parts of this area grass seed was sown broadcast, and trees were planted. (Looking downhill)

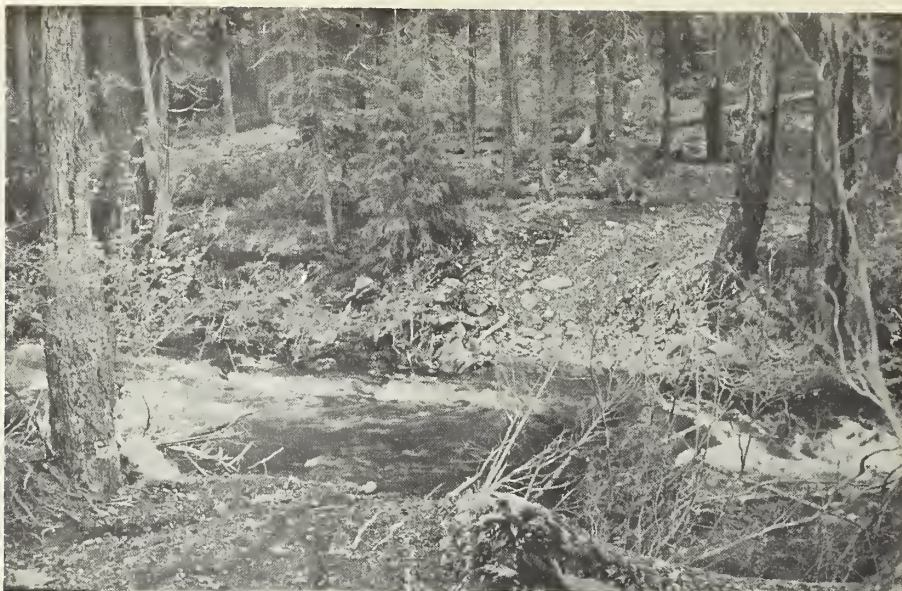
25.

Excellent tractor road crossing of a perennial stream in good location with adequate slope on both banks. This prevents stream diversion into road. All the logs from about 100 acres came out over this crossing with little or no damage to the stream.

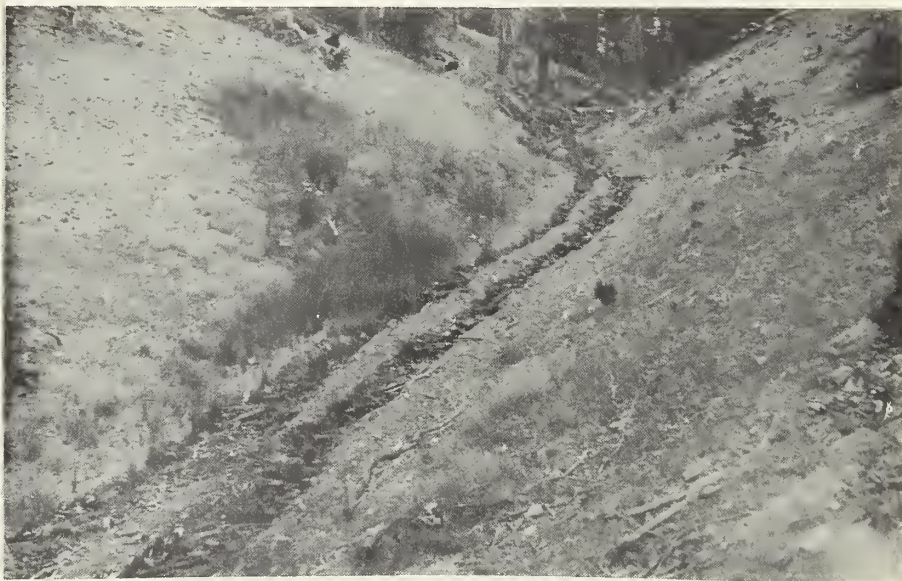
26.

Tractor trail in bottom of a shallow ravine. Even though the watershed is small, there has been considerable erosion from one winter's runoff. Skidding down the intermittent waterway was easy and economical, but after it was done the channel should have been erosion-protected by placement of heavy slash. Under good watershed management the logs from such a basin would have been skidded out over a tractor road on the slope, leaving the streambed undisturbed.

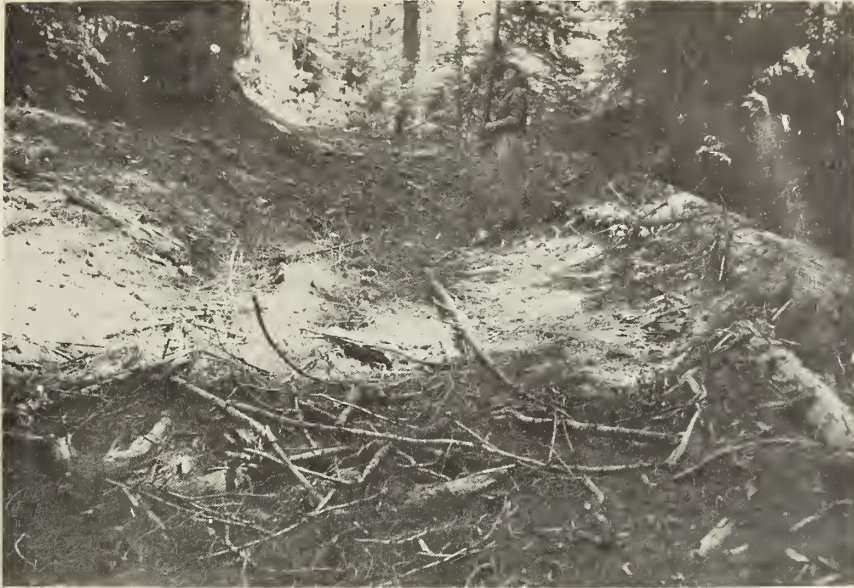
27.

Tractor trail on 30 per cent grade in light d. g. soil, completely stabilized with litter and slash placed by hand. Note the use of fine material and branches. Water break about 60 feet up slope turns water out into timber at right.

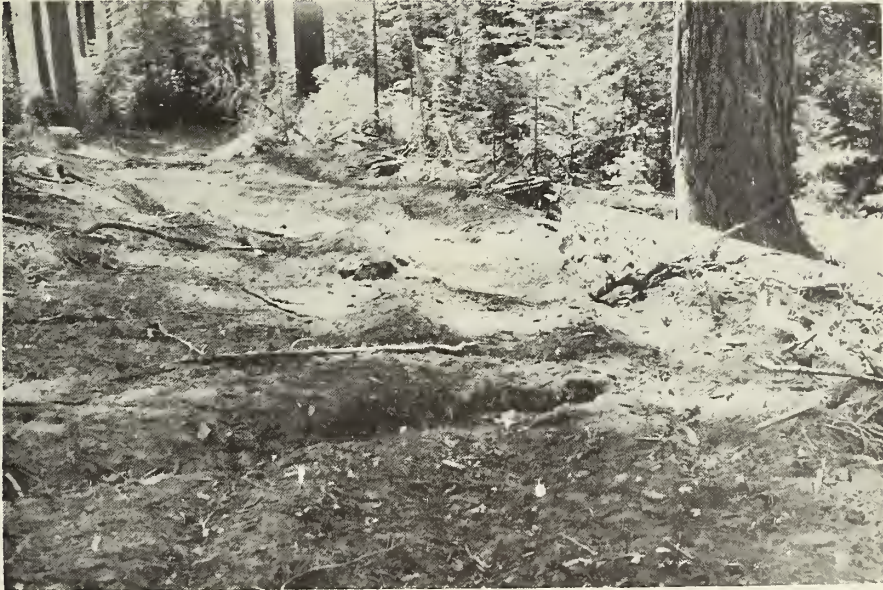
28.

Tractor trail on 20-25 per cent grade in light d. g. soil, well protected by a covering of fine litter about one inch deep, and water-breaks about 100 feet apart, all done by hand. This road withstood a severe storm without perceptible erosion.

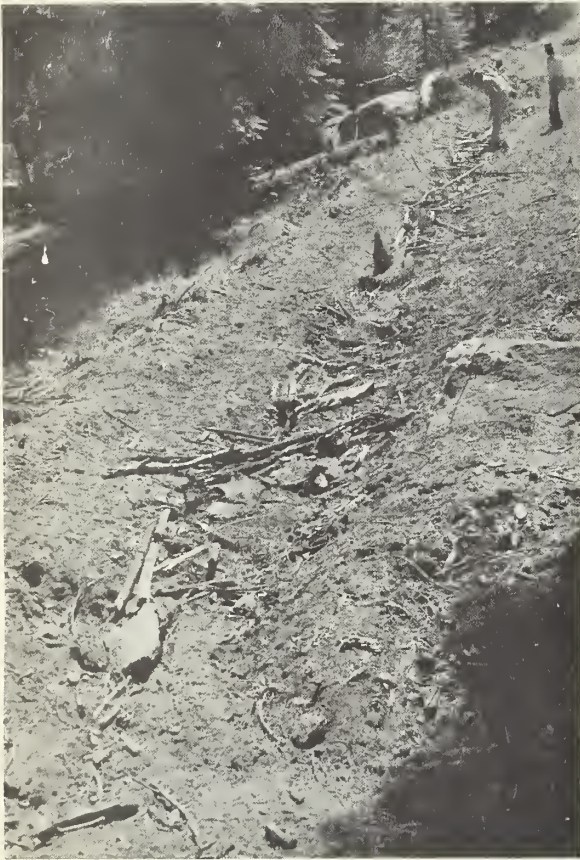
29.

Tractor trail in light d.g. soil, showing a stretch of 35 per cent grade treated by hand placement of light slash. With the water-break visible beyond the men, and one or two additional breaks farther up, this entire trail was effectively erosion-proofed.

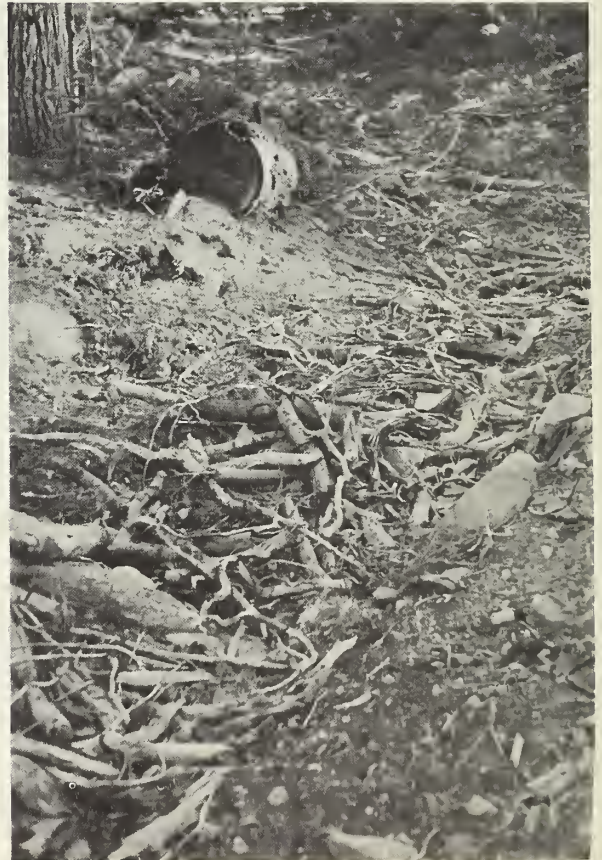
30.

Tractor trail heavily treated with slash placed by hand and crushed into place by one pass of a tractor. Erosion control complete, despite steep grade of 50 per cent and light d.g. soil. Such dense placement of material is seldom necessary, but it may be the only practical treatment for short steep pitches or trough-shaped trails.

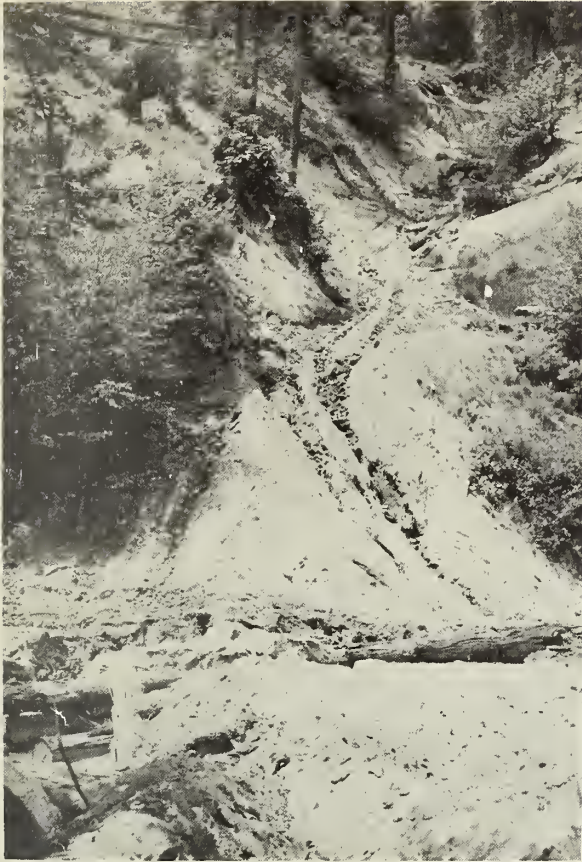
31.

Tractor trail in very light d.g. soil down a steep ravine and across a live stream, with no regard for soil conservation practices. Much material was excavated to make the fill across the creek in foreground and upstream, leaving unprotected slopes and banks. Erosion has been severe, is still active, and stream is heavily silted. This bad situation could have been prevented by proper planning, location, and construction.

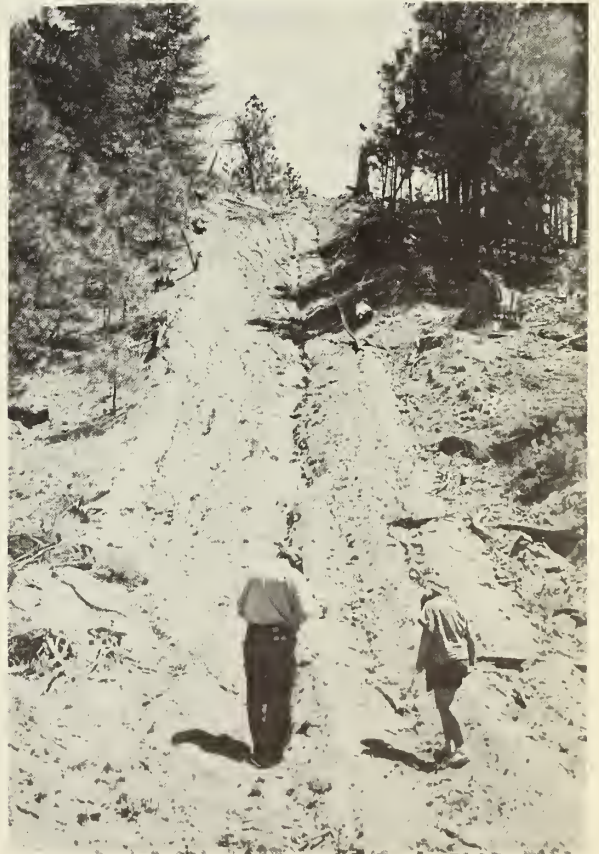
32.

Tractor trail on a steep slope (55 per cent) in light soil, heavily eroded. Actually, this is a "bootleg" trail or shortcut from a well located tractor road around hill to right. Treatment now required consists of water-breaks (one at top and another midway down slope), liberal application of slash, and possibly seeding to grass.

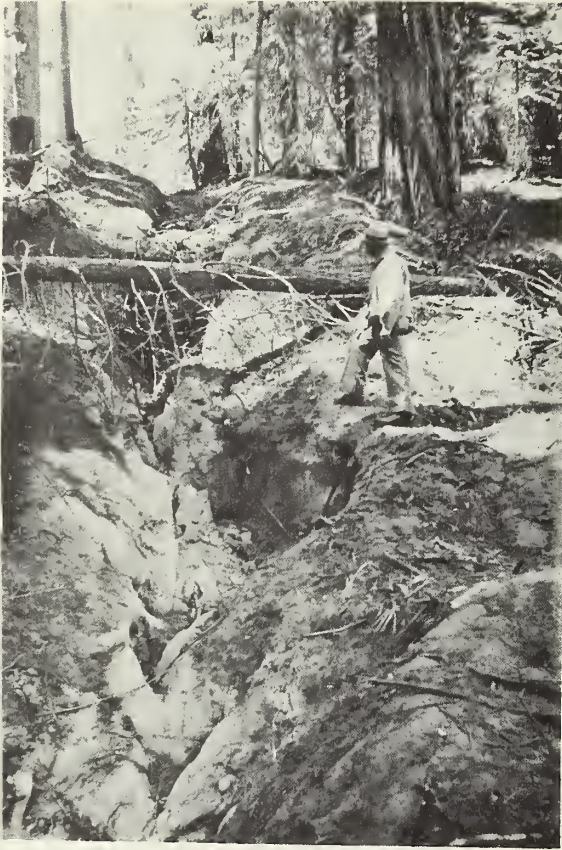
33.

Severe erosion of a short-cut tractor trail down a 50 per cent slope in very light d.g. soil. Erosion to bed-rock at lower end of trail was caused by water accumulated from one-fourth mile of undrained trail above. This trail needed water breaks at about 100 feet intervals, including one at head of this slope, and a good application of slash on the steeper pitches. Moreover, at this spot the trail should have angled down the hillside to the right on a gentler grade.

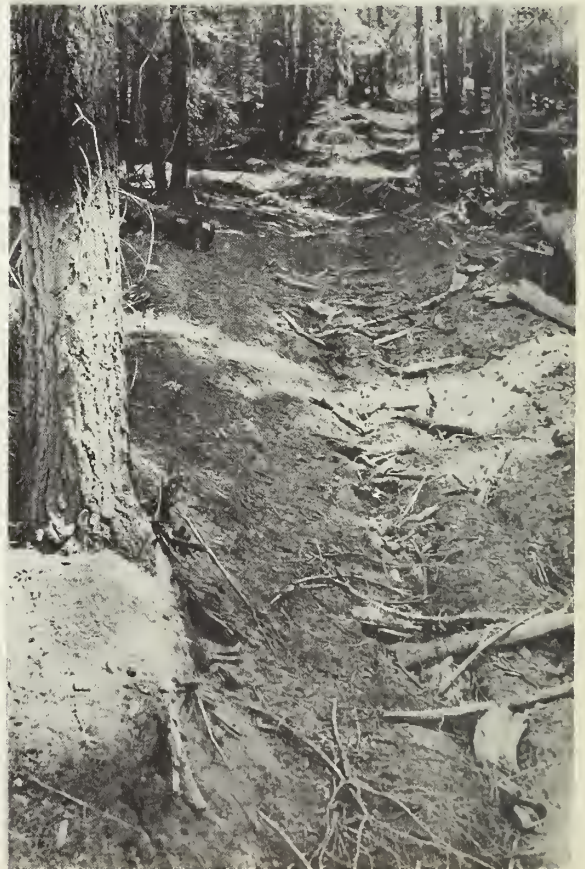
34.

Skid trail "trench" on a 30 per cent slope showing ineffective treatment. Erosion has continued because of poor placement of short pieces of branch wood without proper contact with the ground, and absence of water turn-outs. Large material like this should either be crushed down with tractors or mixed with finer material to create effective water-breaks.

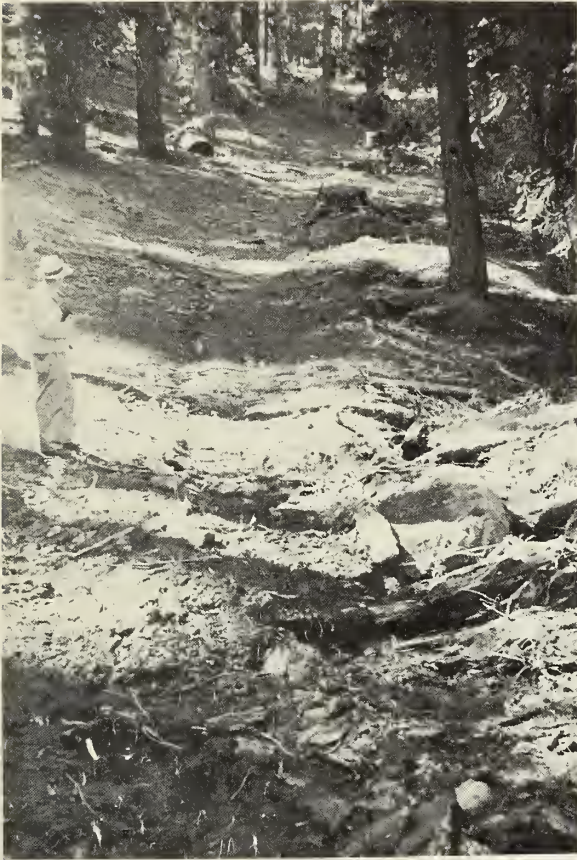
35.

Skid trail beside a small water course. This trail is located well away from the water course and crosses it at a point (in foreground) where it will not divert stream flow. A light treatment with small slash and limbs has held erosion in check thus far, but a heavier application is needed because the light soil is easily eroded.

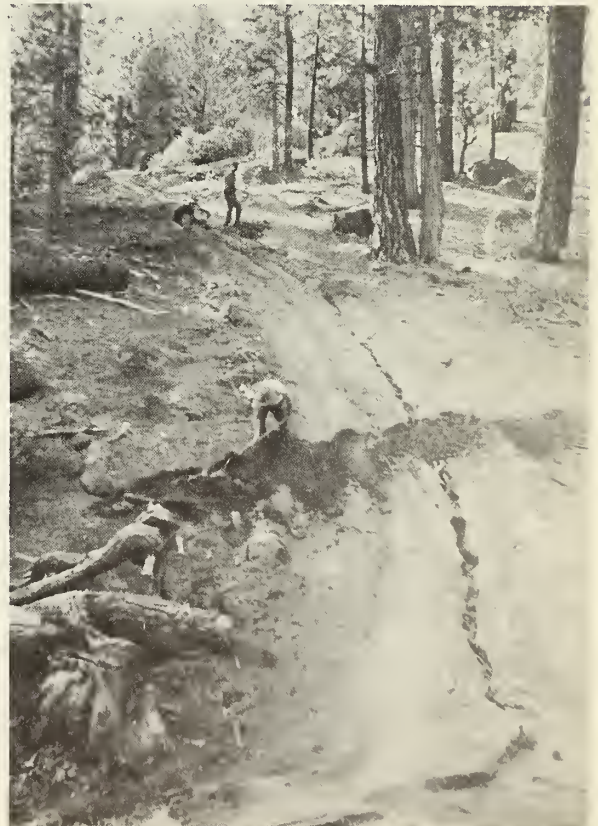
36.

Skid trail on a 30 per cent slope in compacted granitic soil, showing erosion which occurred prior to treatment. The water-break being dug in foreground will divert the water into litter above logs. The man above is placing slash in the gully, but another water-break farther up the slope at the turn might be needed.

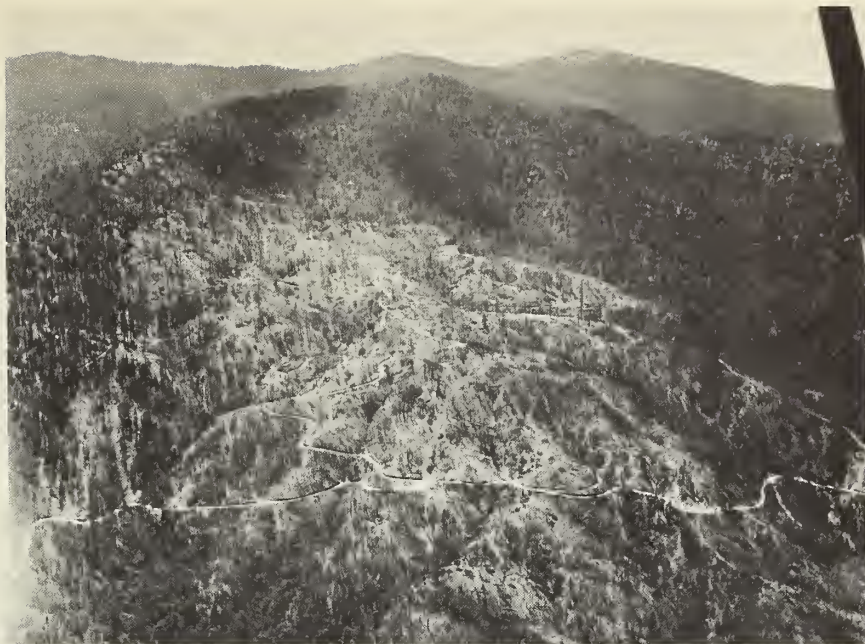
37.

Aerial view of burned area on steep varied terrain showing road and tractor skid trail system used in timber salvage operation.

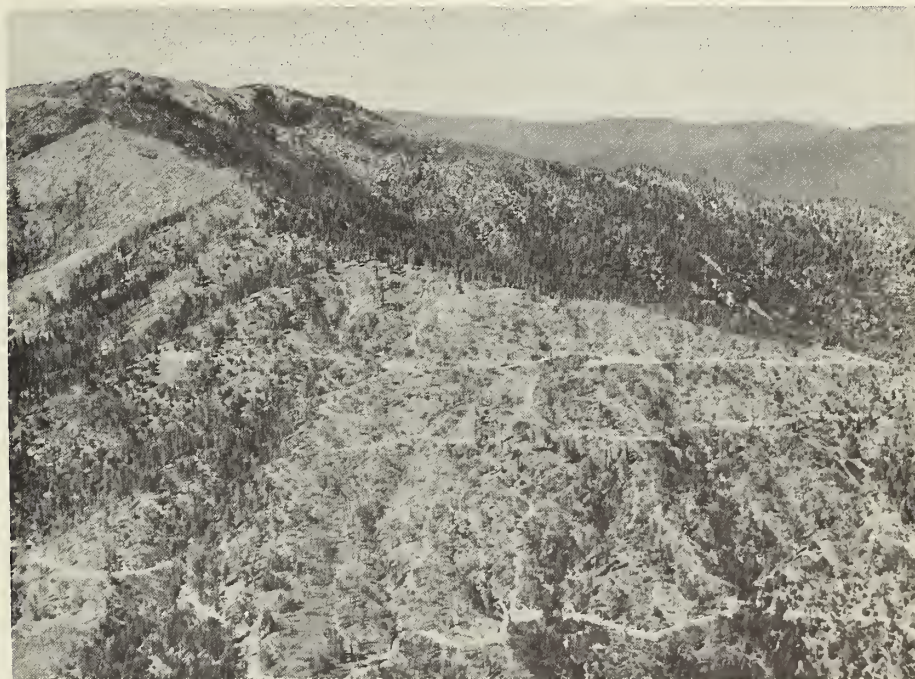
38.

Aerial view of burned area in steep country, with roughly parallel ravines. Parallel contour roads are located to facilitate yarding of logs up or down tractor trails on ridges. This is a normal system layout for tractor logging.

Picture 38 illustrates a marginal type country between that which should be tractor logged to contour roads, and that which can best be logged uphill by high-lead cable methods. The area was logged by tractor to three contour roads. With a high-lead system, one road--the lowest one, which involved the most excavation and erosion--would have been eliminated. The two upper roads would have been spaced farther apart, and the whole area logged with much less soil disturbance.

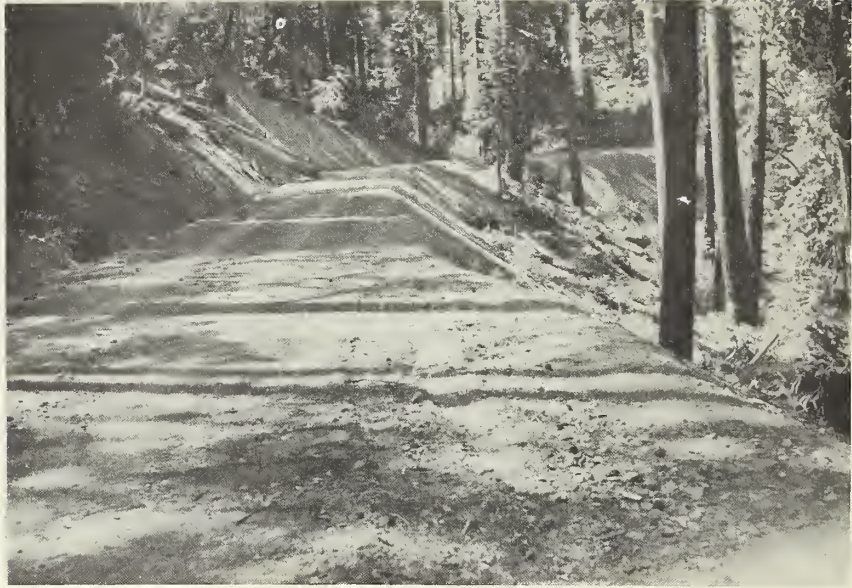
39.

Secondary road on contour location in shale soil.
